Manhole Inspection Summary

Manhole # S25GG1006MH

Insp Date: **10/27/08 11:24 AM**

Location Address: **4032 FALLS RD**

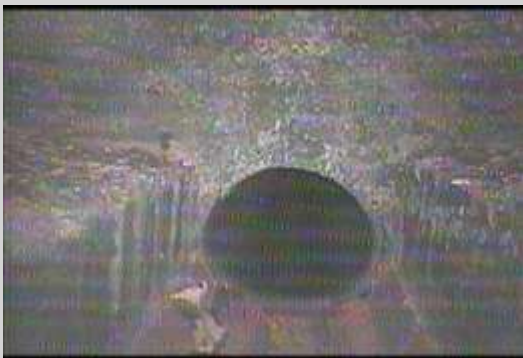
8 in. Circular Gravity Sewer Pipe In @ 6 O'Clock

Pipe Material: **Clay** ☐ Pipe Lined

Infiltration: **None** Pipe Seal Cond: **Unknown**
